## Grooving on runway 11/29

**Company** ÖBA – Österreichische Betondecken Ausbau GmbH

**Principal** Flughafen Wien 2016 Consortium

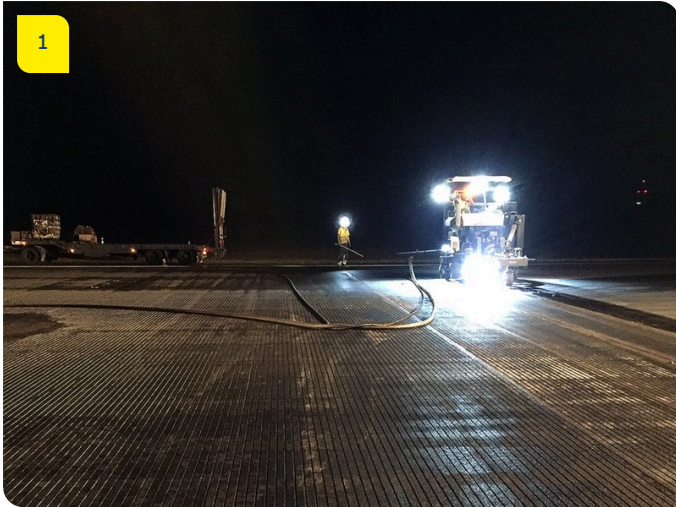
1

Late night grooves.

The bumpcutter was used on 30.000m<sup>2</sup> of runway.

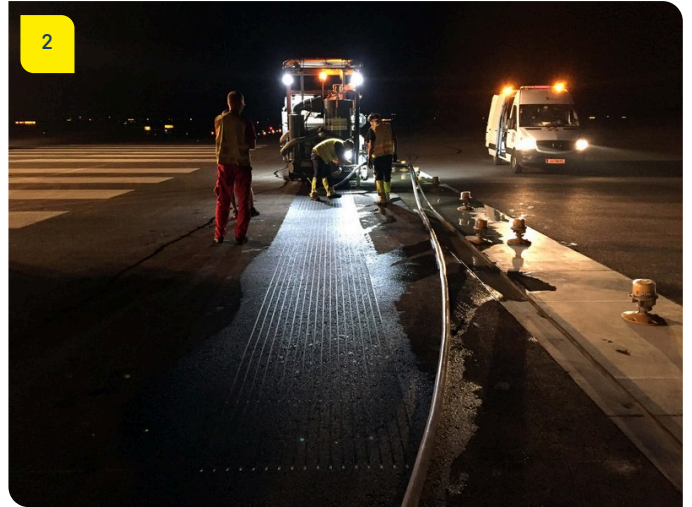
2

On track with the bumpcutter.

Combatting hydroplaning on the runway, section by section.

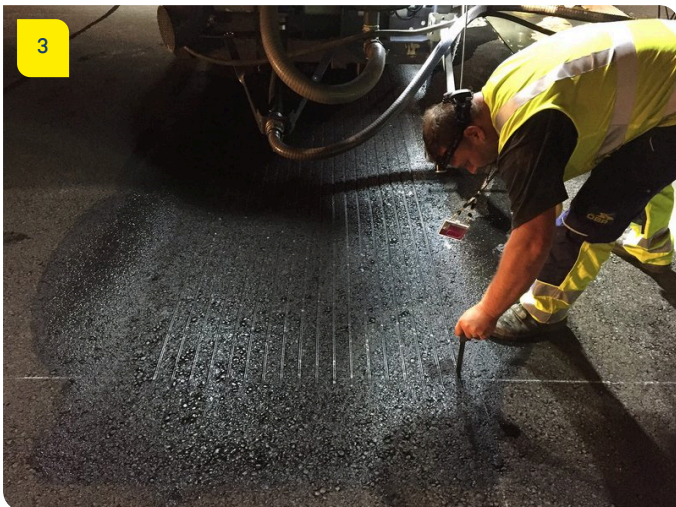
3

A perfectly grooved runway.

Ongoing quality control: precision work is required to ensure perfect water drainage.

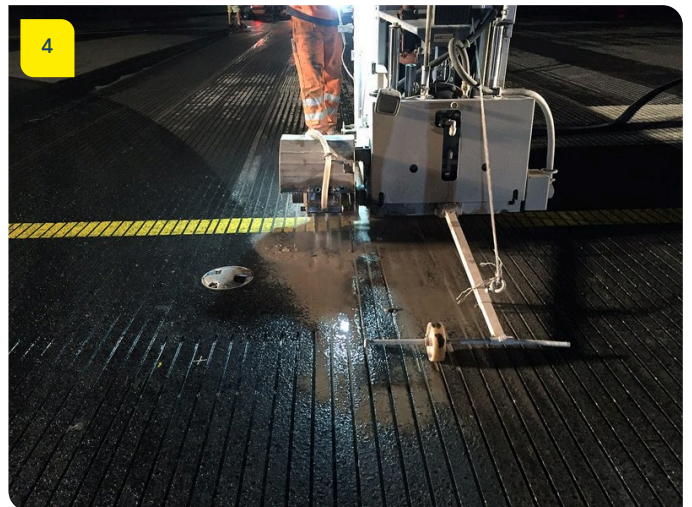
4

Perfectly equipped.

Working around the runway lights is not a problem for ÖBA either – they just use smaller joint cutters.

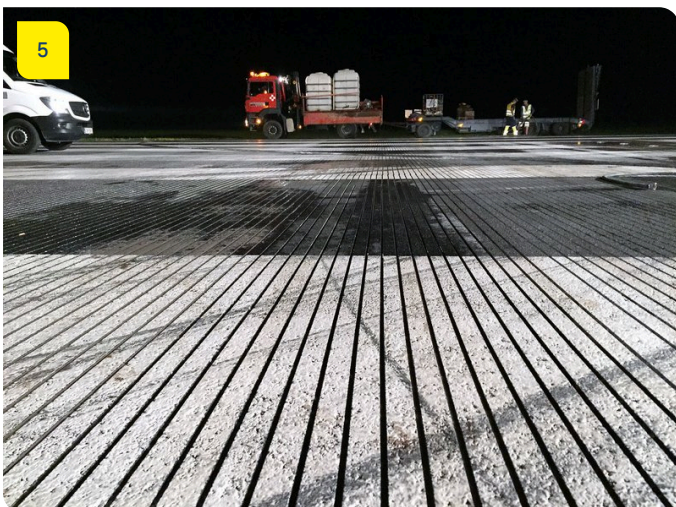
5

Reduced risk of hydroplaning.

The end result fully satisfies all of the employer's high requirements.
