## VIE runway 11/29 rehabilitation – 2016/2

### Data and facts

| Type | Joint, repair and surface technology |

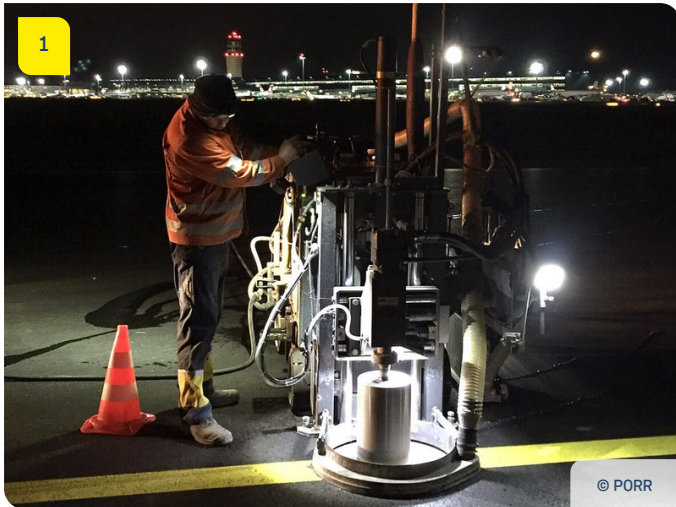
1

Working with heavy machinery by night.

Up to three drills were in use at the same time during the night shifts.

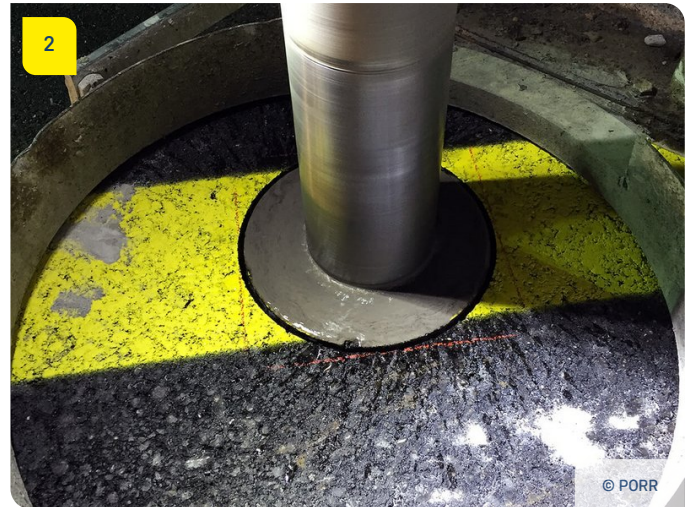
2

With precision and care.

A total of 900 inner and external boreholes were needed to install the runway lighting.

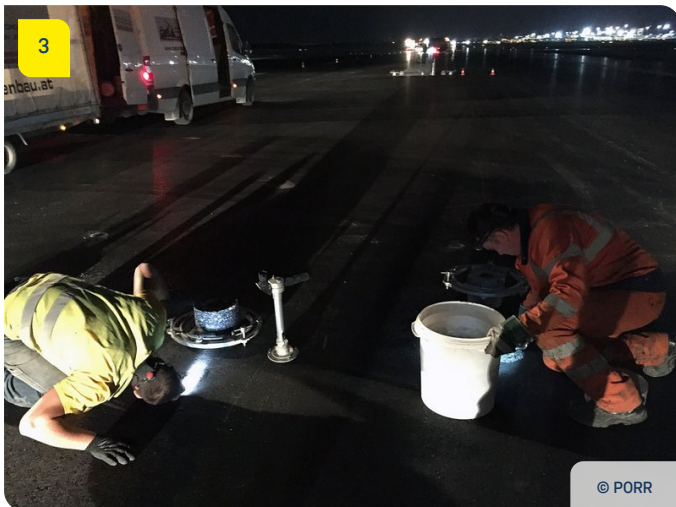
3

Precision work by night.

In order to meet the airport operator's high standards of quality, the greatest precision was required when positioning the runway lights.

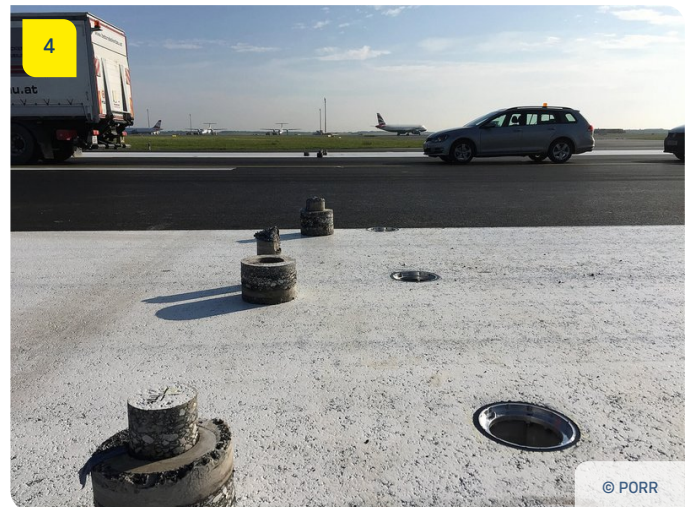
4

Prepare for landing.

In-pavement runway lights installed in the touchdown zone.

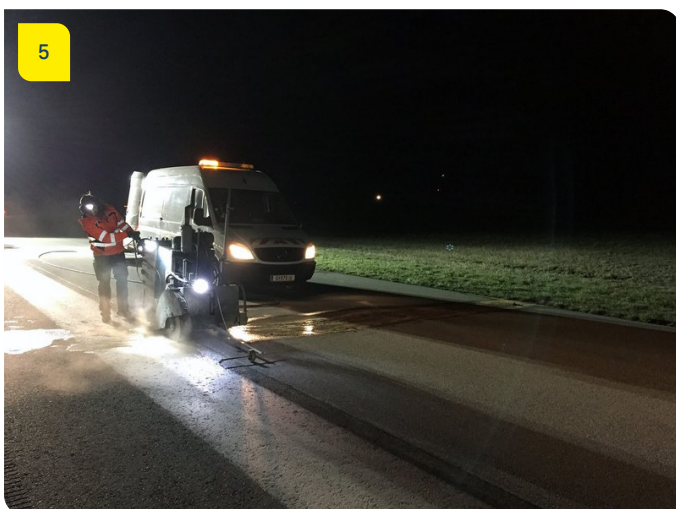
5

Cutting edge engineering.

10,000m of cuts with a depth of 15 to 30cm had to be made before removing the old runway surface.

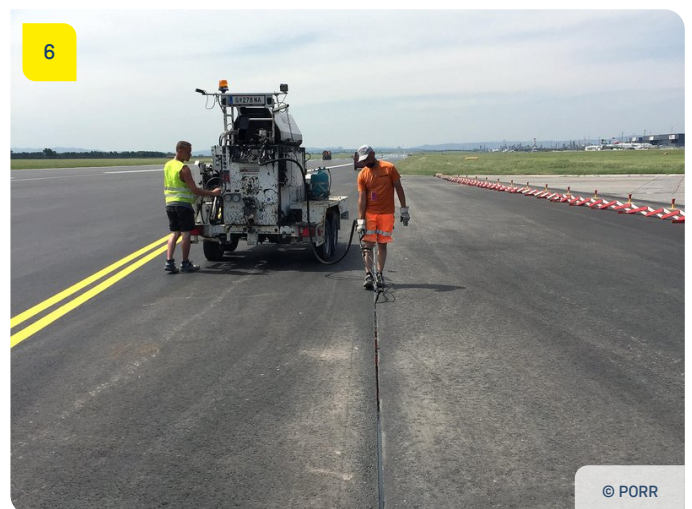
6

Final touches.

In a final step, around 9,000m of joints were sealed with a hot-applied bitumen sealing compound.
