Vienna Repair of the Gutheil Schoder Bridge A23 expressway (Südosttangente)

Repair work on the bridge seal and the mastic asphalt covering.

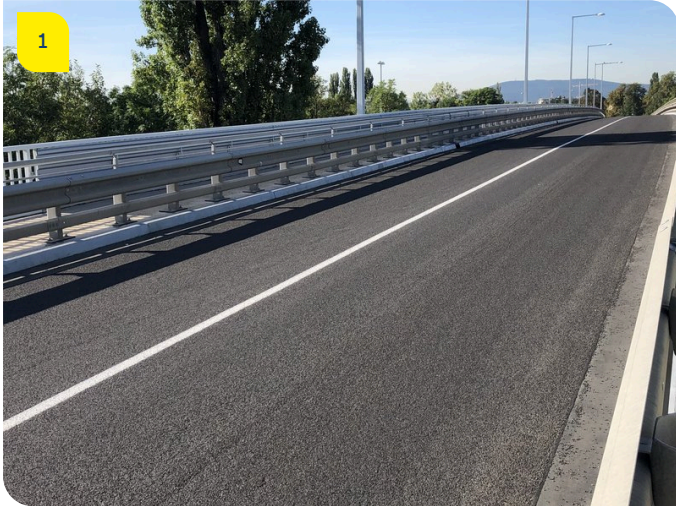
1

Fresh covering and new sealing.

Between July and September 2017, PORR upgraded the Gutheil Schoder Bridge in Vienna's 23rd district.

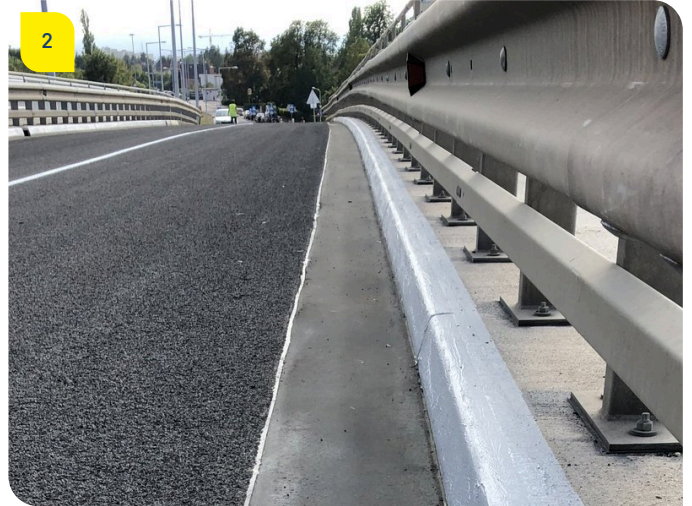
2

Sealed and upgraded.

The sealing connection was applied to the existing steel curbs, which were also provided with corrosion protection.
