Facade construction

Bank Burgenland Eisenstadt

New face for Bank Burgenland

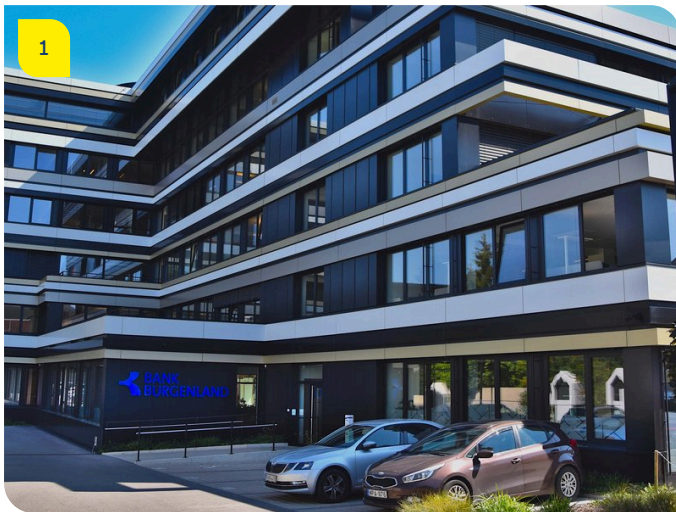
1

Modern façade as the centrepiece.

Thanks to the new façade of Bank Burgenland in Eisenstadt, the building impresses with its modern appearance and light-flooded interior.

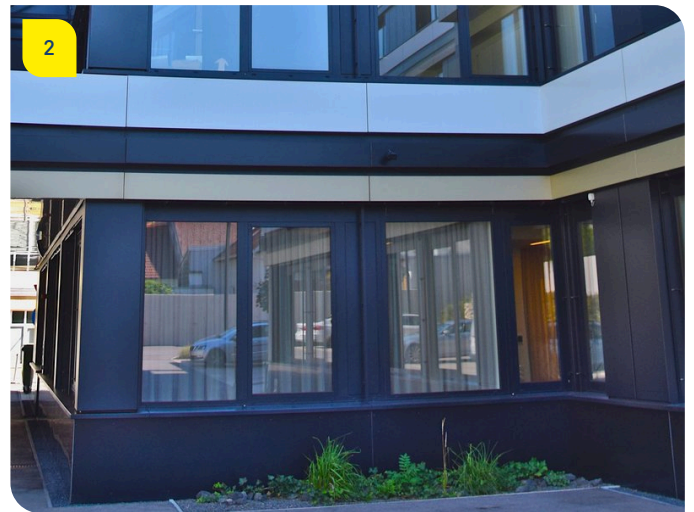
2

Extensive façade construction.

The mullion-transom façade with Alucobond louvre cladding gives the building its urban character.
