# Modernisation of the Nysa Reservoir

## Data and facts

Company	PORR S.A. (leader), Metrostav A.S.
Type	Hydraulic engineering & harbours
Runtime	01.2013 - 05.2016
Principal	Regional Water Management Authority in Wrocław

# Taming an element – modernisation of the Nysa reservoir.

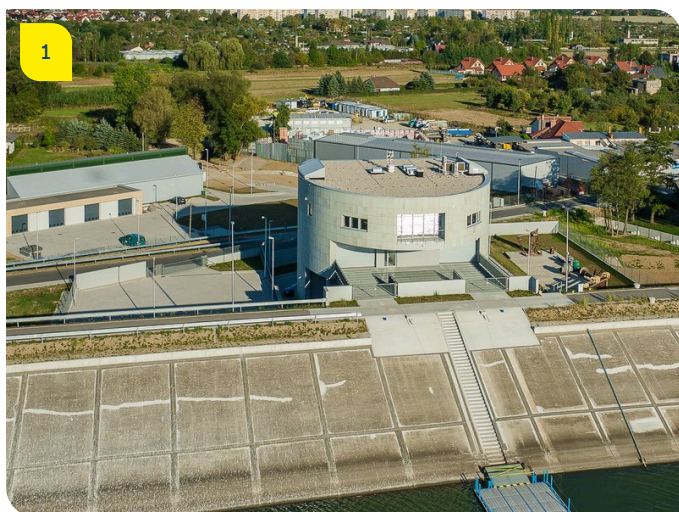
2

Water discharge structure at the reservoir in Nysa.

As part of the project, the water discharge structure of the frontal dam of the Nysa Reservoir was reconstructed and a new bridge and footbridge were built. The automatic control system, the signalling and the visual control system were modernised as well.

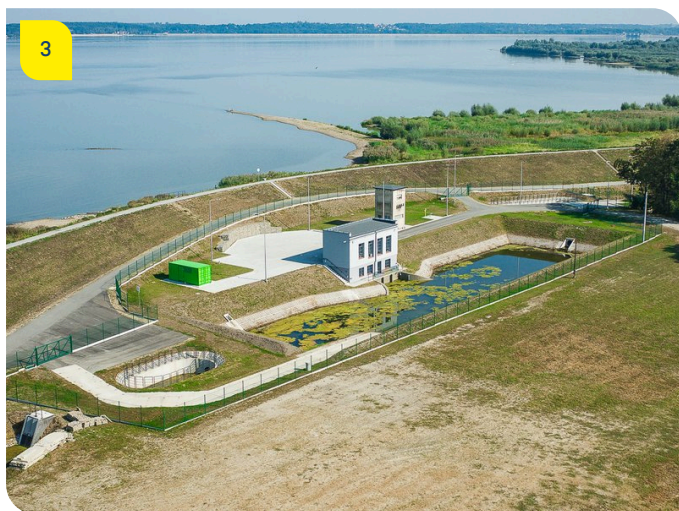
3

Flood protection infrastructure from the Nysa Reservoir modernisation project.

The modernisation project improved the management of the reservoir facilities. The automation of the control system now allows to monitor and control facility operations remotely in the riverbed below the Nysa flood protection dam.
